Home Inspection Report

123 First Street
Avalon, NL
Prepared for: Jane And John Smith

Client: Jane And John Smith
 Date: 10-25-2013

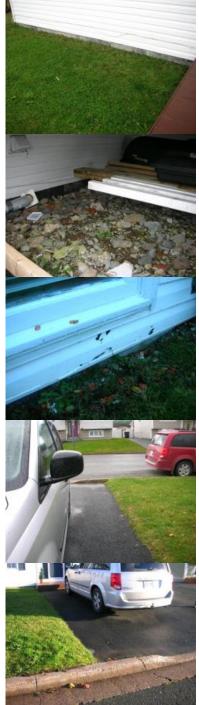
Walls:

Common cracks and holes noted on siding. Repairs are recommended to protect structure from damaging weather. Recommend ensuring all penetrations are sealed as regular maintenance to prevent damaging water seepage. Expect replacement of some framing/sheathing if installing new siding, windows, fascia/soffit(common). Recommend cleaning dryer exhaust vent as regular maintenance for proper operation/prevent possible fire hazard.

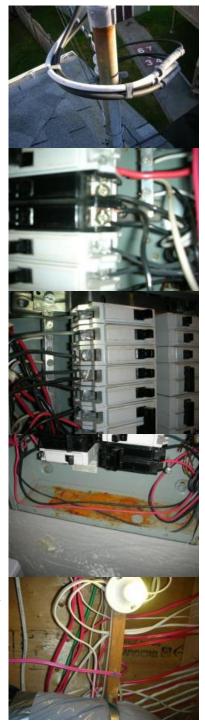
Main panel:

Double taps noted(X2). (two circuits to one breaker), Recommend qualified electrician review/ correct as required to prevent possible nuisance tripping of breakers/ fire hazard. Minor rust noted at base of panel, no moisture at time of inspection. Monitor, seal exterior as required. No room for additional circuits. Upgrading size of panel or installing sub panel will be required if additional circuits required. Ie: adding heat source in laundry rooms and bathroom. To correct double taps.

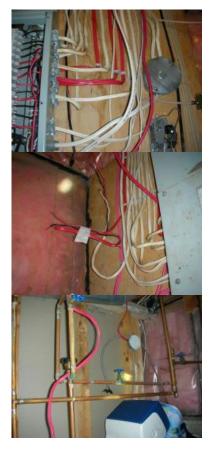
Branch circuits:

Recommend properly terminated branch circuit by water hear and by panel(provide junction box for safety/ (prevent fire hazard). Some poorly supported by main panel. Recommend having electrician review for any remedial correction.
